# FINAL REPORT

Reclamation of Wood Materials Coated with Lead-Based Paint

ESTCP Project SI-0309

March 2009

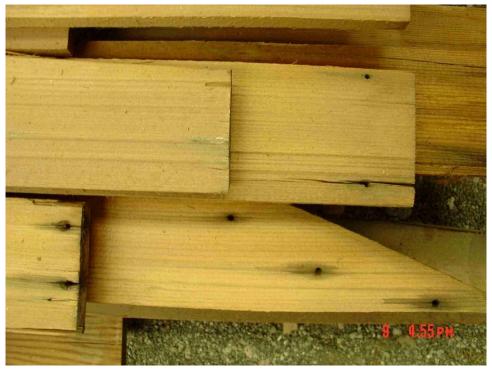
Material losses due to end splits or other conditions requiring end-trimming (Figure 4.7) were observed in a significant number of the 57 blanks surveyed. However, this loss factor equates to 4.7% of the total linear footage. This loss percentage also includes measurements of linear footage with respect to observed lengthwise splitting (Figure 4.8). Little decay from in-service use was found in the blanks, but drilled utility holes were occasionally found (Figure 4.9). Some observed wood discoloration was probably caused by nail corrosion. Of the 57 blanks inspected, 15 had residual LBP remaining after the planing process. Figure 4.11 shows an example.

Figure 4.7. Examples of mitered cuts and end splits that would cause a loss of product yield.

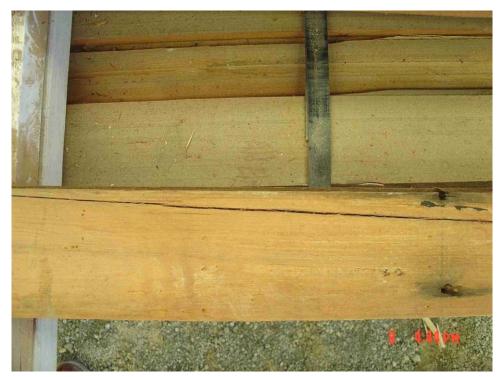
Figure 4.8. Lengthwise split as a defect that would cause a loss of product yield.

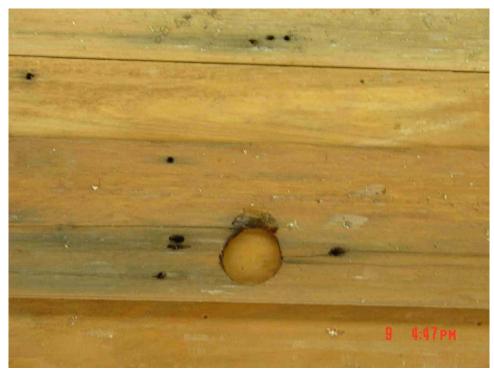
Figure 4.9. Utility holes found in a number of surveyed blank pieces.

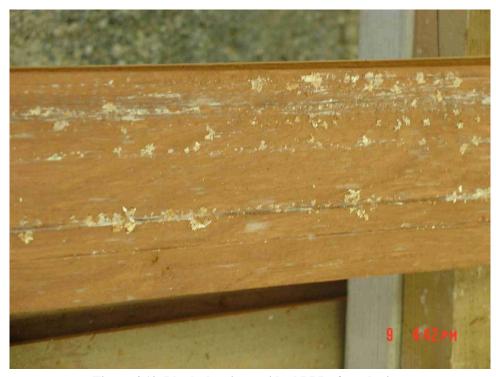
Figure 4.10. Blank showing residual LBP after planing.

As discussed in detail previously, some of the remilled boards emerged from the planing device with some residual LBP adhered to their surface. FPL personnel determined that the problem was caused by feeding the boards too quickly into the planer, and not by any deficiency in the planing equipment itself.

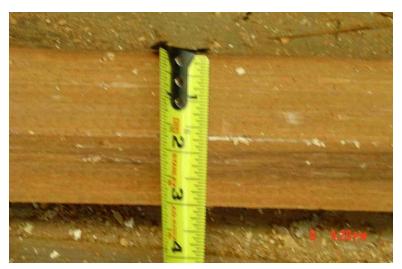
Another common machining problem observed was the creation of undersized blanks. Figure 4.11 illustrates a blank that is nearly 5/16 in. narrower than the target width. The frequency of this machining defect was observed in roughly 25% of the Douglas fir survey sample (i.e.,14 of 57).

Figure 4.11. Produced blank that is too narrow.

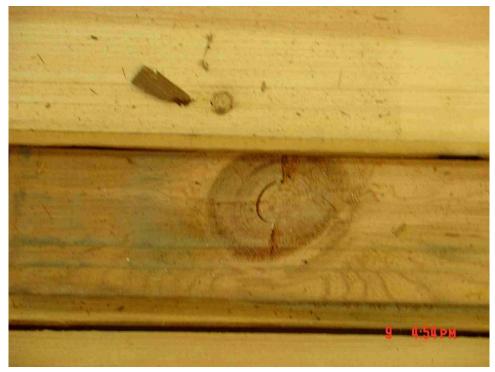
Figure 4.13. Typical size of knot and torn-out knot found in the redwood blanks. This defect was found in relatively few blanks.

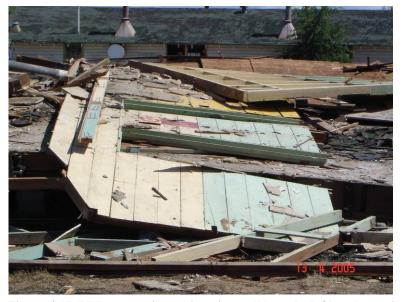
The greatest negative economic impact on this project was an additional \$47,562.50 reimbursement to AGSC for hazardous waste disposal costs that the company had not anticipated in its price proposal. AGSC processed only a portion of the 1 x 8 interior wall finish boards, and none of the painted 2 x 4 wall studs through the MU (Figure 4.17). Because the MU had been adjusted to process the 1 x 6 exterior siding boards, planing the two painted sides of the 1 x 8 interior boards would have required two passes, effectively doubling the labor requirement. The planer was capable of performing this operation, however, as AGSC and ERDC-CERL personnel processed 5,000 lf of the 1 x 8s. Processing the 2 x 4 studs would have required another readjustment of the planing device and also two passes to remove paint from all four sides of the stud. For purposes of holding down project labor expenses, the AGSC superintendent elected to dispose of those materials instead of milling them. That unilateral decision was inherently burdened by its own cost inefficiency, however, insofar as it created a significant and unanticipated load of bulky hazardous waste that had to be handled in accordance with laws and regulations. ERDC-CERL believes that AGSC's decision to dispose of the painted materials in order to reduce labor costs was not economically viable, and that it was more costly that it would have been to process the wall boards and studs through the planer.

Figure 4.17. LBP-contaminated interior wall boards (left) and exterior wall studs (right) destined for landfill.
